WEATHERING OF THE GABBRO STONES OF THE UNKNOWN SOLDIER MONUMENT (MT. AVALA, SERBIA)

MATOVIĆ, V. & VASKOVIĆ, N.

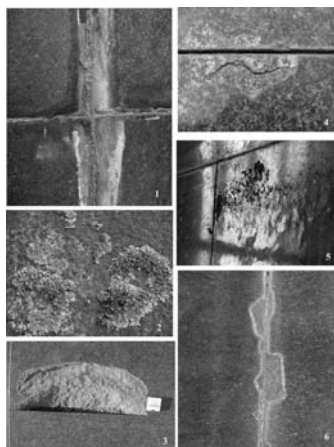
The results of the first mapping have shown a great variety of weathering forms (loss of stone material, discoloration/deposits, detachment of stone material and fissures/deformation), and a wide range of intensity. Damage such as break-out, discoloration, crust deposits, granular disintegration, contour scaling, flaking and biological colonization, are observed both on the exposed and sheltered stone surfaces of the monument (Fig. 2).

Fig. 2: Weathering forms: 1. Incrustation; 2. Lichen; 3. Contour scaling & granular disintegration; 4. Flaking; 5 Blistering and roughening; 6. Contour scaling and light-coloured crust.
