LANDSCAPE CHANGES ALONG THE TISZA RIVER IN THE SOUTH TISZA REGION OF HÓDMEZŐVÁSÁRHELY

Z. HEGEDŰS¹ and B. DURAY²

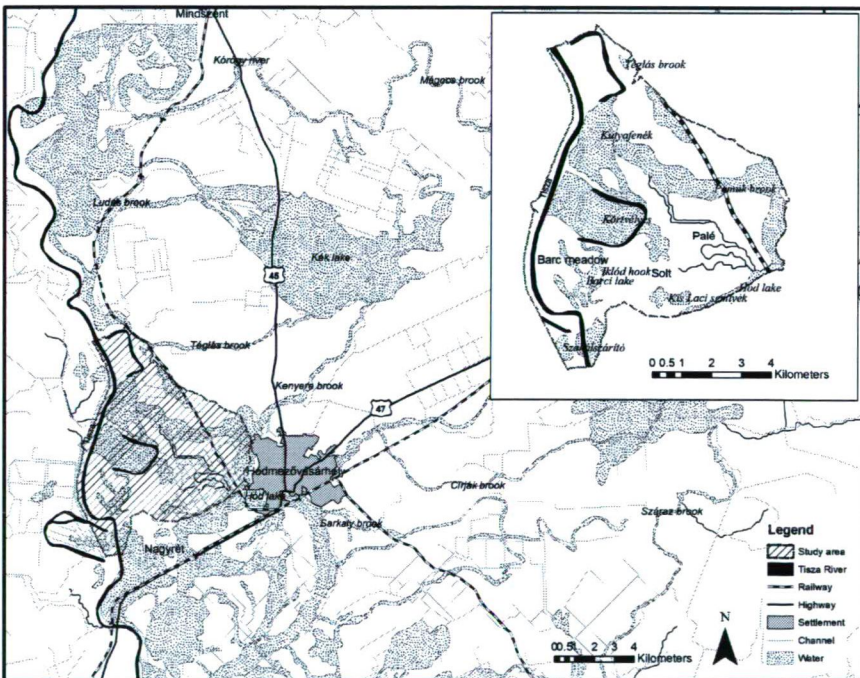
Fig. 1 Study area

On the basis of old maps, landscape monographs and the recognisable morphological signs Hódmezővásárhely and its surroundings were relatively homogeneous hydrological units before the river regulations. Our research concentrated on the area (Fig. 1) where the courses of development of the dike-divided landscapes vary significantly. The boundary of the drainage area was the Kőrös river in the north and the Száraz brook in the south. The waters of Mágocs and Újváros were channelled to the Tisza river by the Kőrös river through the Mágocs brook. It also fed the once extensive Kék lake through some hooks. The water surplus of the lake was syphoned by the Ludas brook and also by the Téglás and Kenyere brooks. The recipients of the *dűlő*'s waters between Rárós and Mártély were mainly the Kenyere brook, the plane areas of the Kenyere and Pap brooks, the flat territories of the settlements of Palé and Solt, the Hód-lake and the Nagyrét meadow. Furthermore several unnamed and empty river beds demonstrate that the north-west areas were directly related to the Tisza river and its flat territories. The pastures around the settlement of Vásárhely had their own recipients (lakes and flat lands). In case of heavy rainfalls their water moved towards the town to the Csomorkány flat lands or it was led to the Hód-lake through the Kis-tó bend, the Cirják-brook and the Sarkaly-brooks.

We analysed the landscape changes in the sample area shown in Fig. 1. Our goal was to examine the nearly 150 years of dramatic landscape change in an area where a complete scale of human impacts can be traced. By doing so we have gained insight into

land use which consolidates the preservation of natural structures and at the same time has transformed the landscape as the result of human activities. The almost 60 km² sample area is part of the Mártély Nature Conservation Area of the Kiskunság National Park and includes the areas surrounding Hódmezővásárhely. The north-east and south-east boundaries of the area are the Mártély-Hódmezővásárhely and the Bodzás roads.

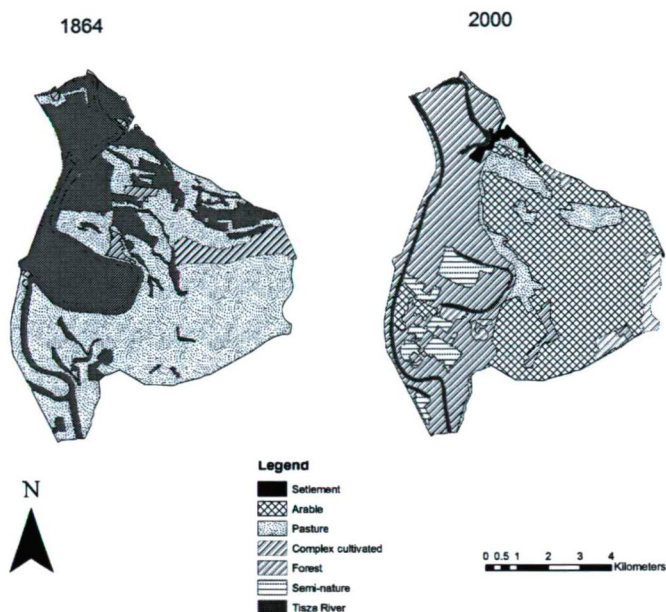
Fig. 2 Land cover changes between 1864 and 2000

On the basis of the analyses on the differences between the land use demonstrated by the second military survey in 1864 and the present-day one it can be ascertained that the

approximately one-and-a-half-centuries long development of the landscape resulted in significant modifications in the area (Fig. 2).

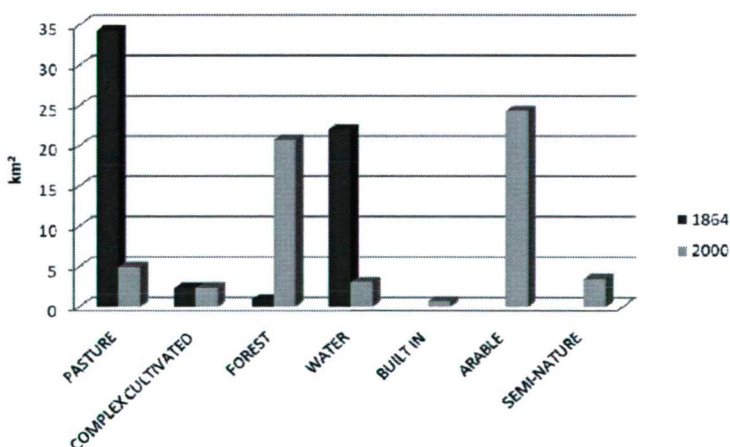
Fig. 3 Land cover changes between 1864 and 2000

By 2000 only half of the original ways of land use was observable (52%), furthermore the structural proportions of the types notably changed (Fig. 3). The area of pastures decreased by approximately 50% (from 58% to 8%). The area of forests (mainly in the protected areas) increased by 33%, water surfaces were diminished by 32%. The most

spectacular new form of land use is the crop production in arable lands in the place of the former pastures and meadows.
