CHARACTERIZATION AND CHANGES IN THE STATE OF THE LAKES IN THE FIELD OF AGGTELEK AND SLOVAK KARST

A. SAMU and I. BÁRÁNY-KEVEI

Summary – Karstic lakes belong to the natural values of karst. Some of these are very significant land elements, important as habitat as well as aesthetic attraction. Currently most of the lakes are strongly eutrophicated. That is mainly the result of traditional karstic land use shifting to intensive farm production and also increased sewage inflow. We monitored the quality of four lakes on the Aggtelek and Slovak karst: the Papgödör-lake (Farárova jama), the Vörös-lake, the Aggteleki-lake and the Kender-lake. We measured some chemical and physical parameters to check the state of these lakes. In the analysis we determined the changes in the parameters and according to the operative Hungarian standard we carried out a complex water quality assessment for the year 2008.

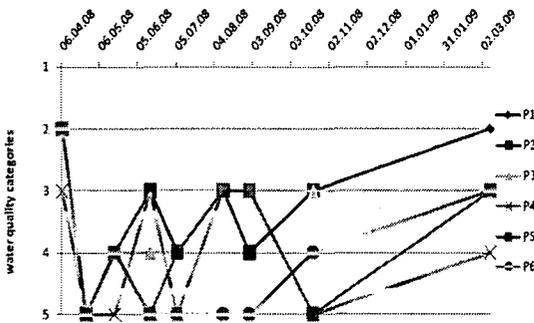
Fig. 2 Summarized water quality of the Papverme-lake

On the basis of the summarized water quality score of the Papverme-lake (Fig. 2) – not taking into account the 6th sampling point (the sewage inflow) – we can state that the water quality in the year 2008 varies mainly between the 3rd and 4th water quality category. The parameters most affecting this 'tolerable' and 'contaminated' quality are oxygen saturation, chemical oxygen demand, ammonium and pH.

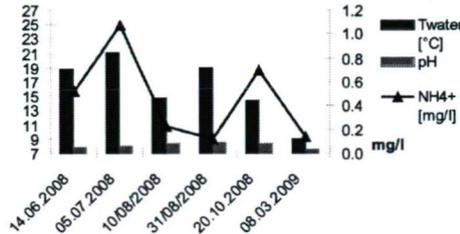
Fig. 5 NH_4^+ – in the function of temperature and pH – Papverme-lake

The high pH values together with higher ammonium and temperature values show that the ratio of free and poisonous ammonia is higher (Fig. 5).

The oxygen saturation and the COD are in the contaminated and strongly contaminated category in every month and so is the ortophosphate except in April and the beginning of August. The pH is even more alkaline than in the case of Papverme-lake (7.8-10.8). Here the ratio of NH_3 is higher than in the Papverme-lake (Fig. 9).

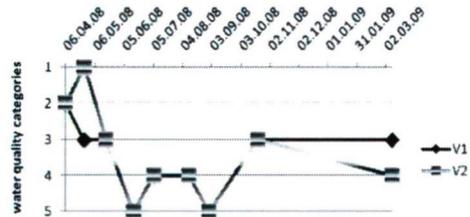
Fig. 6 Summarized water quality of the Vörös-lake

Basically it can be stated that the Vörös-lake shows the best water quality. Its values on the summarized water quality table (Fig. 6) – which, according to the standard mean bad-quality contaminated water – can be considered the result of the amount of the iron, which has been measured since June 2008. However in this case the geological milieu of the lake must be taken into account; red soils surround it so presumably its fauna has adapted to this environment therefore the high iron content does not mean contamination in this case.

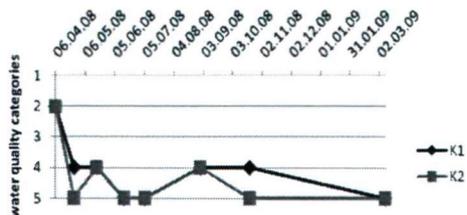
Fig. 7 Summarized water quality of the Kender-lake

The water quality of the Kender-lake is steadily in the 4th and 5th category throughout the year. (Fig. 7). One responsible is the COD, fluctuating between the contaminated and strongly contaminated categories. Iron values are also higher here but the

surrounding soils are also rich in iron. In the second sampling place (K2) we measured also higher manganese values.

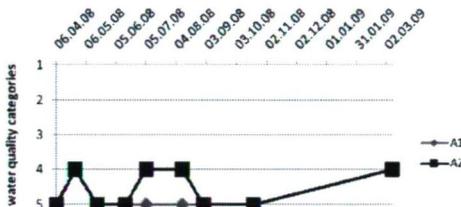
Fig. 8 Summarized water quality of the Aggteleki-lake

The water quality of the Aggteleki-lake is visibly the worst according to most measured parameters (Fig. 8).

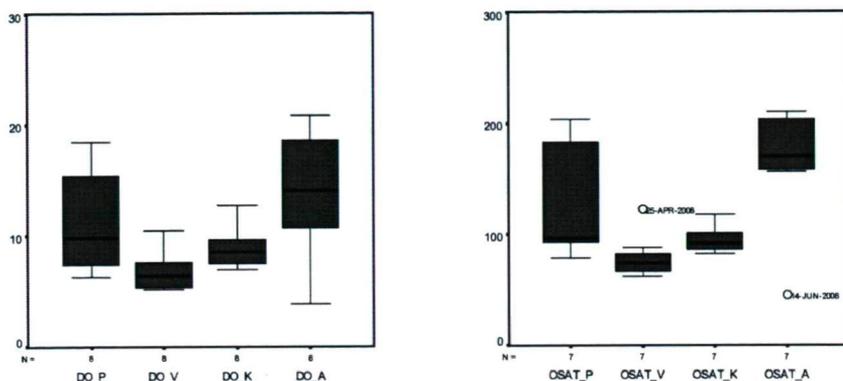
Fig. 10-11 Dissolved oxygen (DO) and oxygen saturation in the lakes

On Fig. 10 and 11 the statistical parameters of the dissolved oxygen and oxygen saturation are shown. It is visible that in the case of the Papverme- and especially the Aggteleki-lake the oxygen balance is very unstable – caused by the algae mass proliferating in these lakes. The water quality of the other two lakes is good according to these parameters.

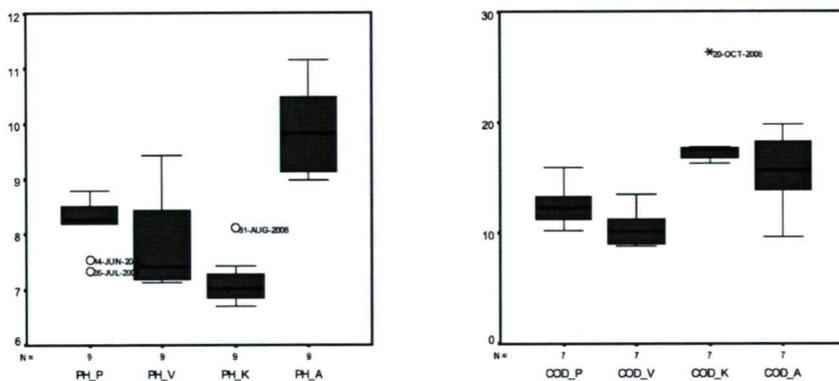
Fig. 12-13 pH and chemical oxygen demand in the lakes

The Papverme and the Aggteleki-lake behave similarly also in the case of the pH (Fig. 12), in both lakes is it very alkaline, while in the other two lakes it is mostly around normal.

In the case of the COD it is visible that the group formulating cause is different; here mainly the size and the water supply of the lakes play the main role. This means that the two smaller lakes (Kender and Aggteleki) can harder process a bigger amount of organic matter (Fig. 13.).

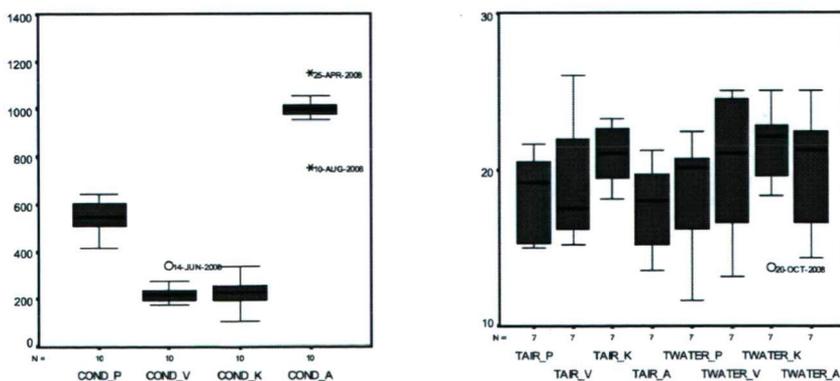
Fig. 14-15 Conductivity and temperature of the air and water in the lakes

Looking at the conductivity (Fig. 14) it is visible that the water of the Aggteleki-lake contains the biggest amount of dissolved ions; it is followed by Papverme-lake which nevertheless only contains half of the amount measured in Aggteleki-lake. In the other two lakes the conductivity and therefore the amount of dissolved ions is small.

Water and air temperature move around 18-20°C in all lakes in the year 2008. Water temperature is often higher than air temperature especially in the case of the smaller lakes (Fig. 15). By the Vörös and Aggteleki-lake there is also no shadowing.
