14th-16th-CENTURY DANUBE FLOODS AND LONG-TERM WATER-LEVEL CHANGES IN ARCHAEOLOGICAL AND SEDIMENTARY EVIDENCE IN THE WESTERN AND CENTRAL CARPATHIAN BASIN: AN OVERVIEW WITH DOCUMENTARY COMPARISON

Andrea Kiss^{1,2*}, József Laszlovszky³

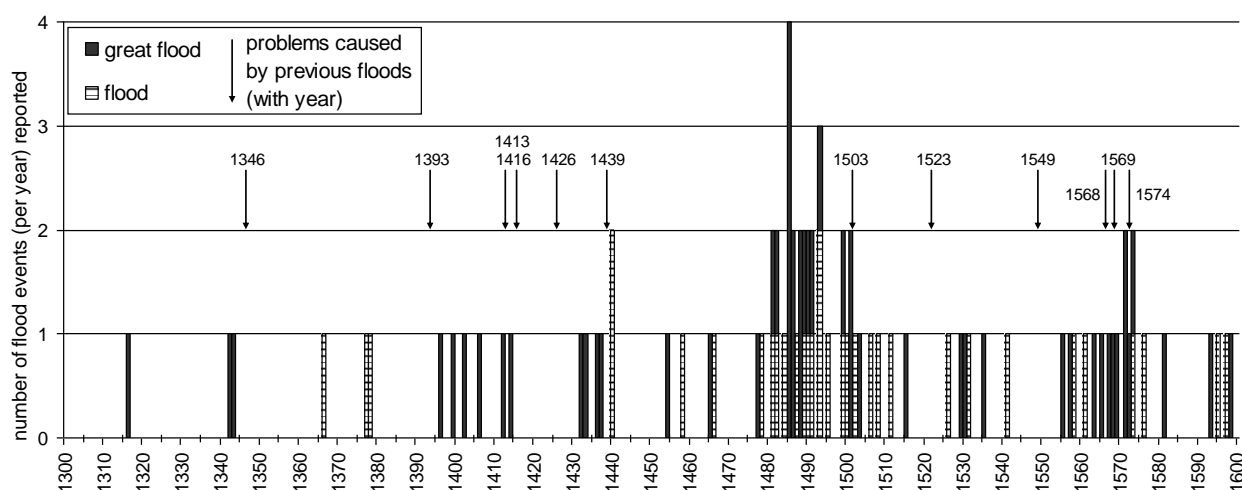
Fig. 1 14th-16th-century Danube floods in the Carpathian Basin, based on presently available documentary evidence (Sources: Kiss, 2012a, 2012b; Kiss and Laszlovsky, 2013)

Documentary evidence is mainly related to individual flood events or the relatively short-term consequences of preceding great flood events and therefore mainly provides high-frequency information. Archaeological and sedimentary evidence is mainly connected to the consequences of great or catastrophic flood events, flood-rich periods and long-term hydrological changes. Since dating of these events, periods and processes, with using natural scientific and archaeological methods, are usually possible on a multi-annual, multi-decadal level, archaeological and sedimentary data on floods are good indicators of medium- and low-frequency changes in flood behaviour. Nevertheless, documentary evidence can provide an important help in the possible more exact dating of flood events or flood peaks whose impacts could be observed in archaeological (and sedimentary) evidence (for presently available data, see: Fig. 1).

As a possible parallel, described in an official letter in 1549, short before the Danube at Bratislava also partly changed its bed, and floods were actively damaging the town walls (see Kiss, 1908; for more details see: Kiss, 2012b). Concerning this case, Ortway (1912) suggested that – similarly to the cases described by Fieber and his colleagues at Orth – an avulsion of the Danube channel occurred at Bratislava, and made the town walls (which were anyway in bad condition) more prone to destructive flood events. It is quite probable that this later event had connections to the great 1548 flood in Vienna mentioned above. Moreover, a number of flood events were also reported in contemporary documentation concerning the 1550s, and the great floods occurred practically in each year around the turn of the 1560s and 1570s (see Fig. 1).

The archaeological data on late 15th–early 16th-century floods is in good agreement with the information detected in documentary evidence: one of the most important (and certainly best documented) medieval flood peaks took place exactly around the decades of the 1480s, 1490s and 1500s (see Fig. 1).

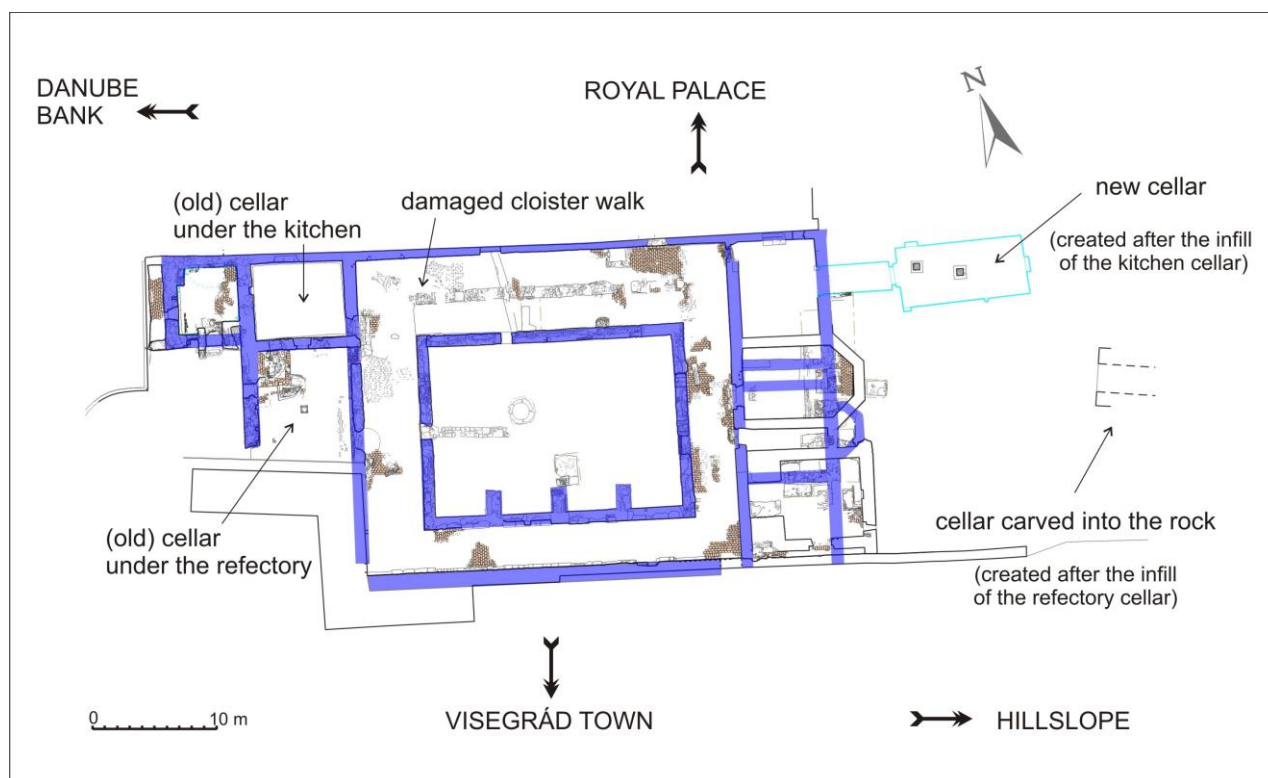
Fig. 3 Layout of the excavated early 15th-century Franciscan friary in Visegrád

Two re-building phases were also detected during the archaeological investigation of the friary. One of them took place during the Matthias-period (1458–1490, with a building activity ca. 1470–80s), while the larger, almost total re-building of the complex happened during the first decade of the 16th century. During this new building phase, another significant rise of the ground level was initiated, which can be clearly detected in the layers of the cloister garth and under the pavement of the cloister walk. Already in this phase one of the two cellars in the western wing, under the newly constructed kitchen has been filled up with earth and a small new cellar was erected in the eastern wing of the cloister, close to the hill slope, behind the building complex (see Fig. 3).

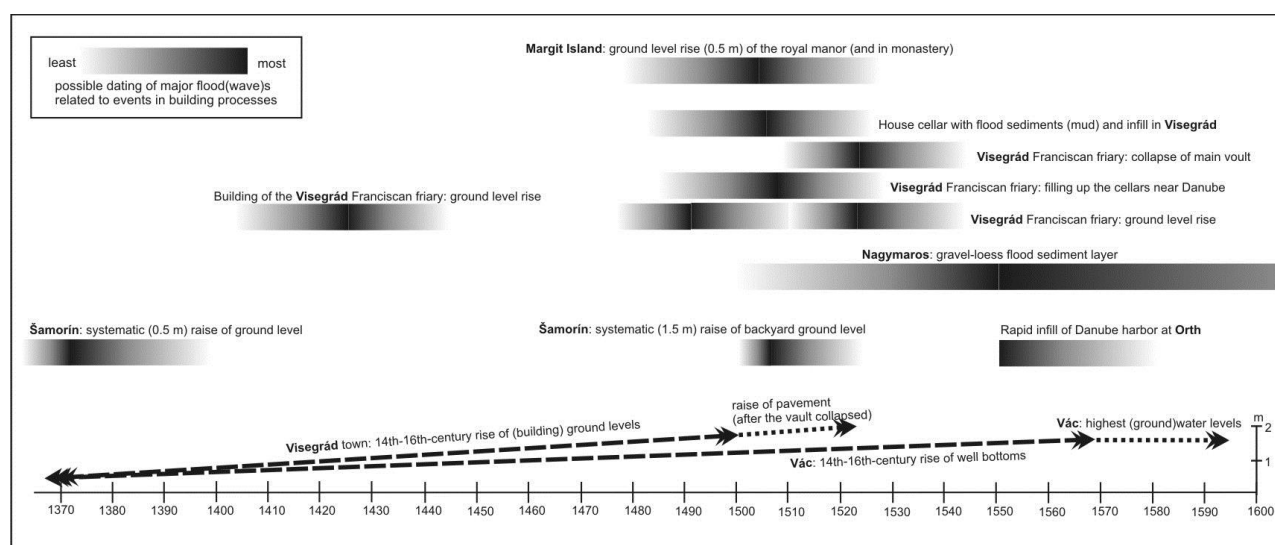
Fig. 4 An overview of 14th–16th-century Danube flood related archaeological-sedimentary evidence in the West and Central Carpathian Basin

As for a conclusion and discussion of results, it is useful to have an overview of the evidence listed above according to main reference periods (see Fig. 4).
